# Diagnosis of the automatic gearboxes 0AM and 02E

Self-study programme

Important **technical modifications** are described in this brochure, which have been carried out since the publication of the above mentioned SSP.

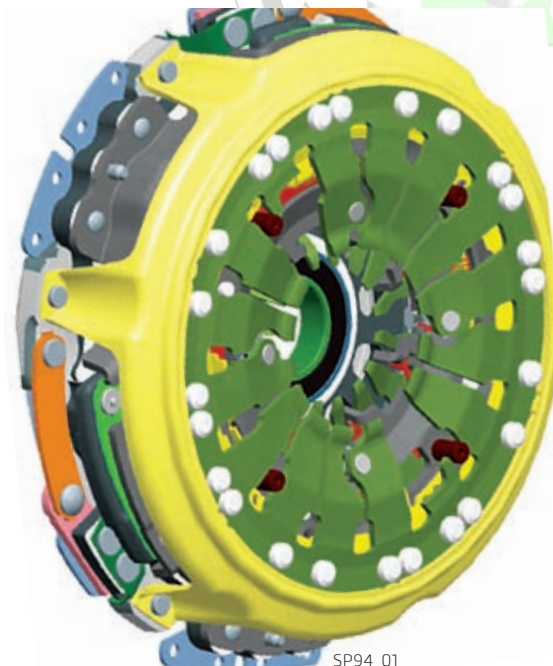
SP94\_01

On the seven-speed automatic transmission OAM, changes in the design of the clutch were carried out as of 01.06.2011.

The modified clutch cannot be exchanged against the original clutch which was fitted up to the stated date.

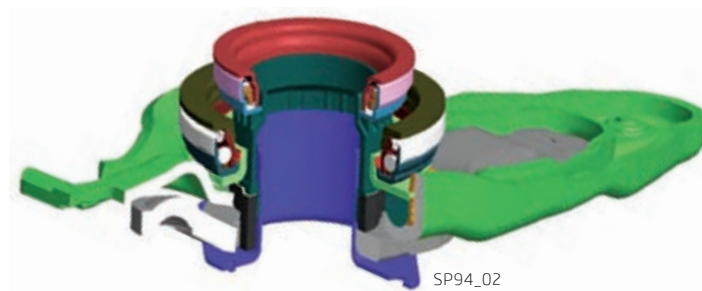
SP94\_02

- a) Design modifications to the cut-off levers of the clutches - Replacement of forgings by plate compacts (changing the lever's shape).

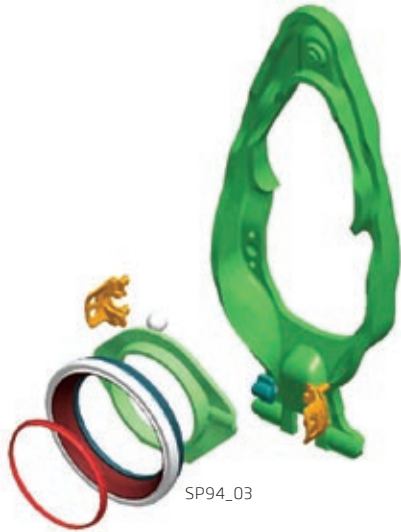
b) Modified bearing on the new version of the cut-off lever for the clutches

new assembly of the lever on clutch K1\*  
(as of 01.06.2011)

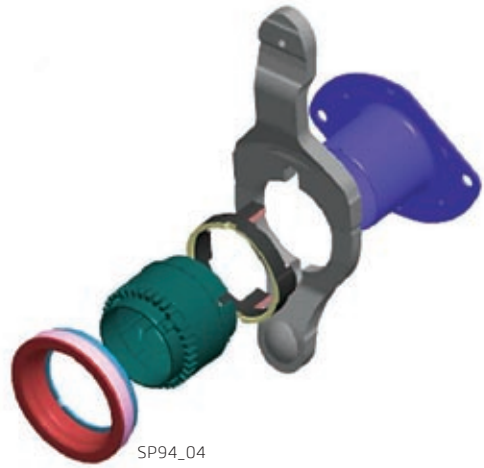
new assembly of the lever on clutch K2\*  
(as of 01.06.2011)

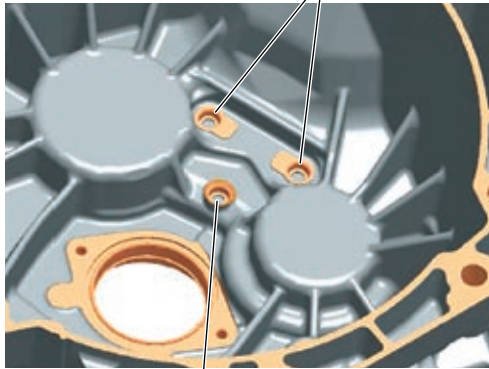
SP94\_05

c) Changes to the shape of the housing on the dual-clutch and modified bearings of the clutch levers in the housing

new bolt bearing of the lever on  
clutch K1\*

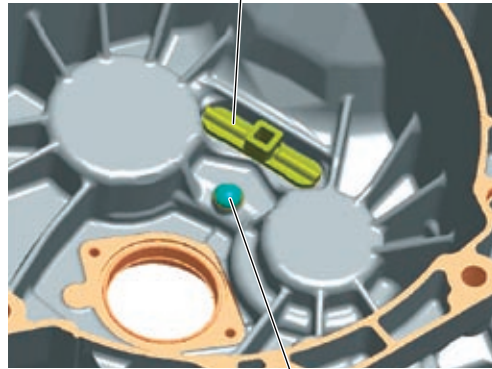
SP94\_06

new bolt of the lever on  
clutch K1\*

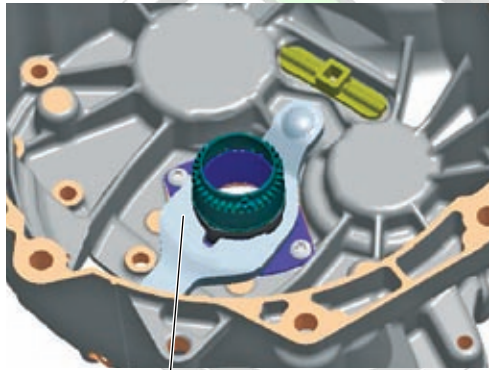
SP94\_07

new bolt bearing of the lever  
on clutch K2\*

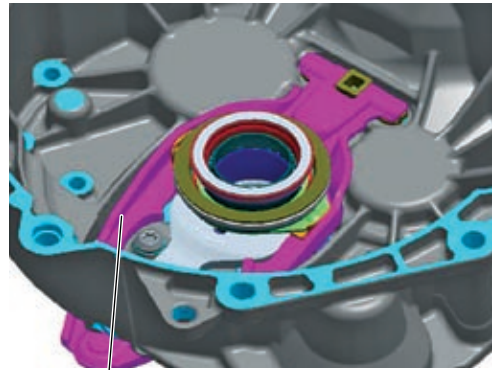
SP94\_08

new bolt of the lever on  
clutch K2\*

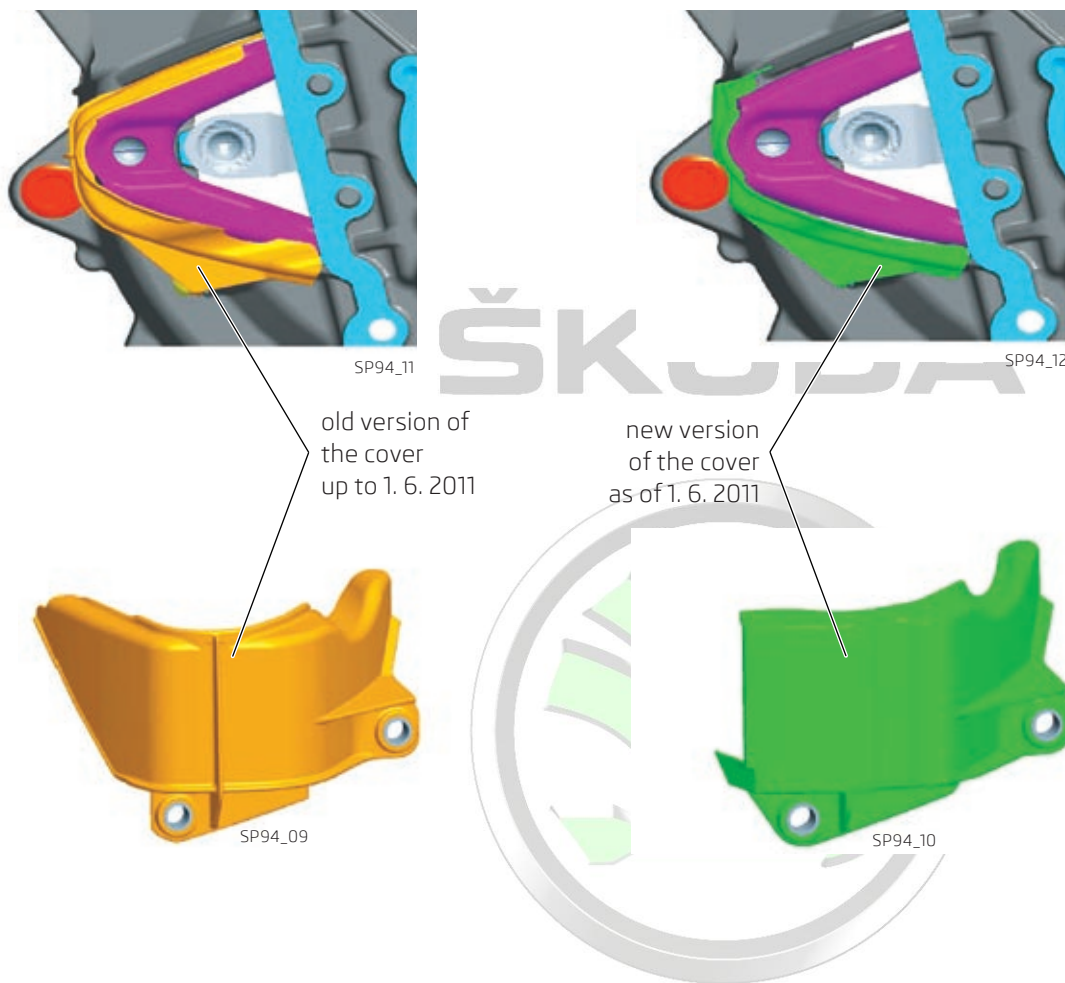
d) Modification of the clutch lever cover (depending on the changes carried out to the shape of the lever):

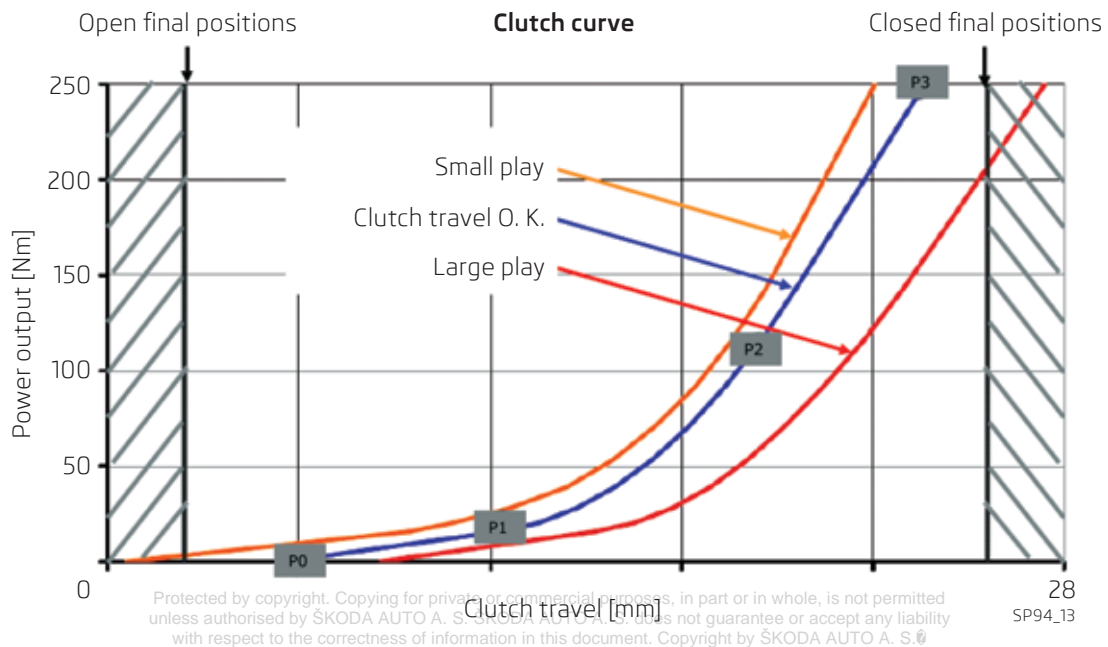
**Clutch characteristic curve**

- Blue curve: The characteristics of the clutch are O. K.
- Red curve: The clutch closes already at 200 Nm, however it should transmit a torque of up to 250 Nm. The customer complains about weak engine power, the vehicle can also jolt.
- Yellow curve: The clutch is engaged, which can be determined from the measured value blocks 5.3 and 5.4.

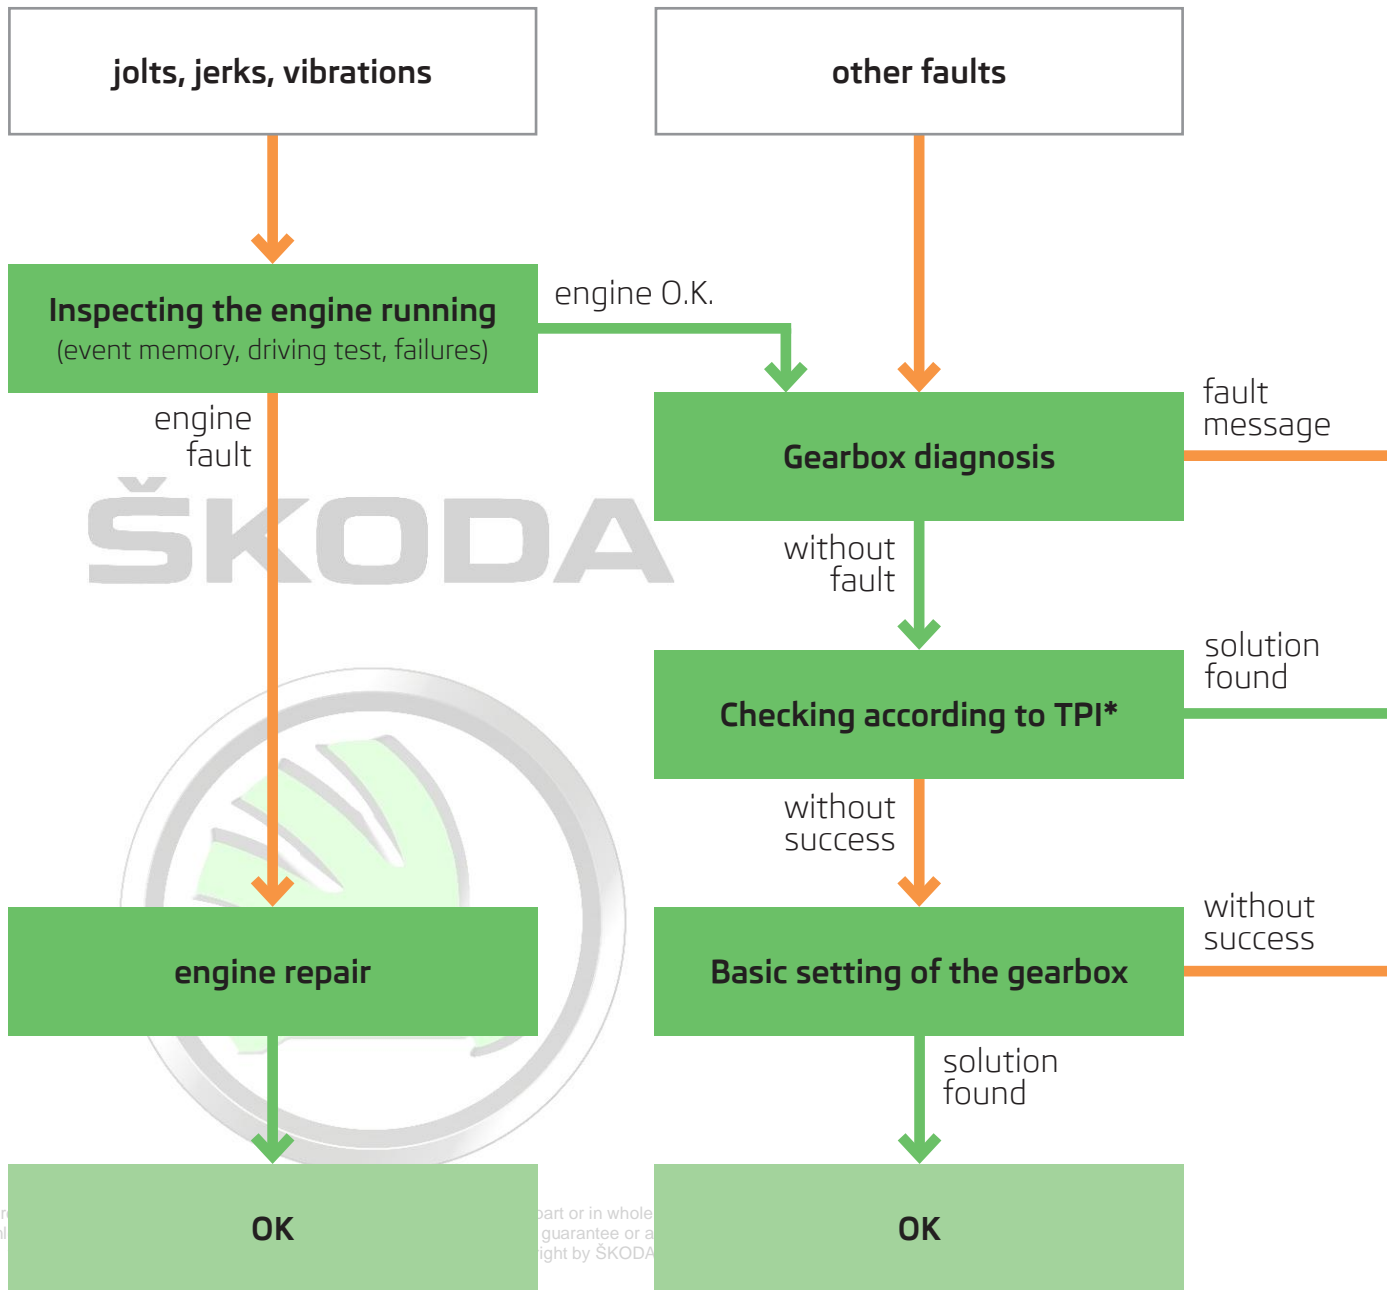
### 3.2.4 Diagram of the recommended procedure for repairing the seven-speed gearbox OAM

This is only valid for faults resulting from the operation.  
 (the diagram refers neither to the faults occurring after the repair nor to the faults occurring after replacing the gearbox components).

\* Checking according to TPI: Do not only check the fault but also the manufacturing period, referring to the TPI.

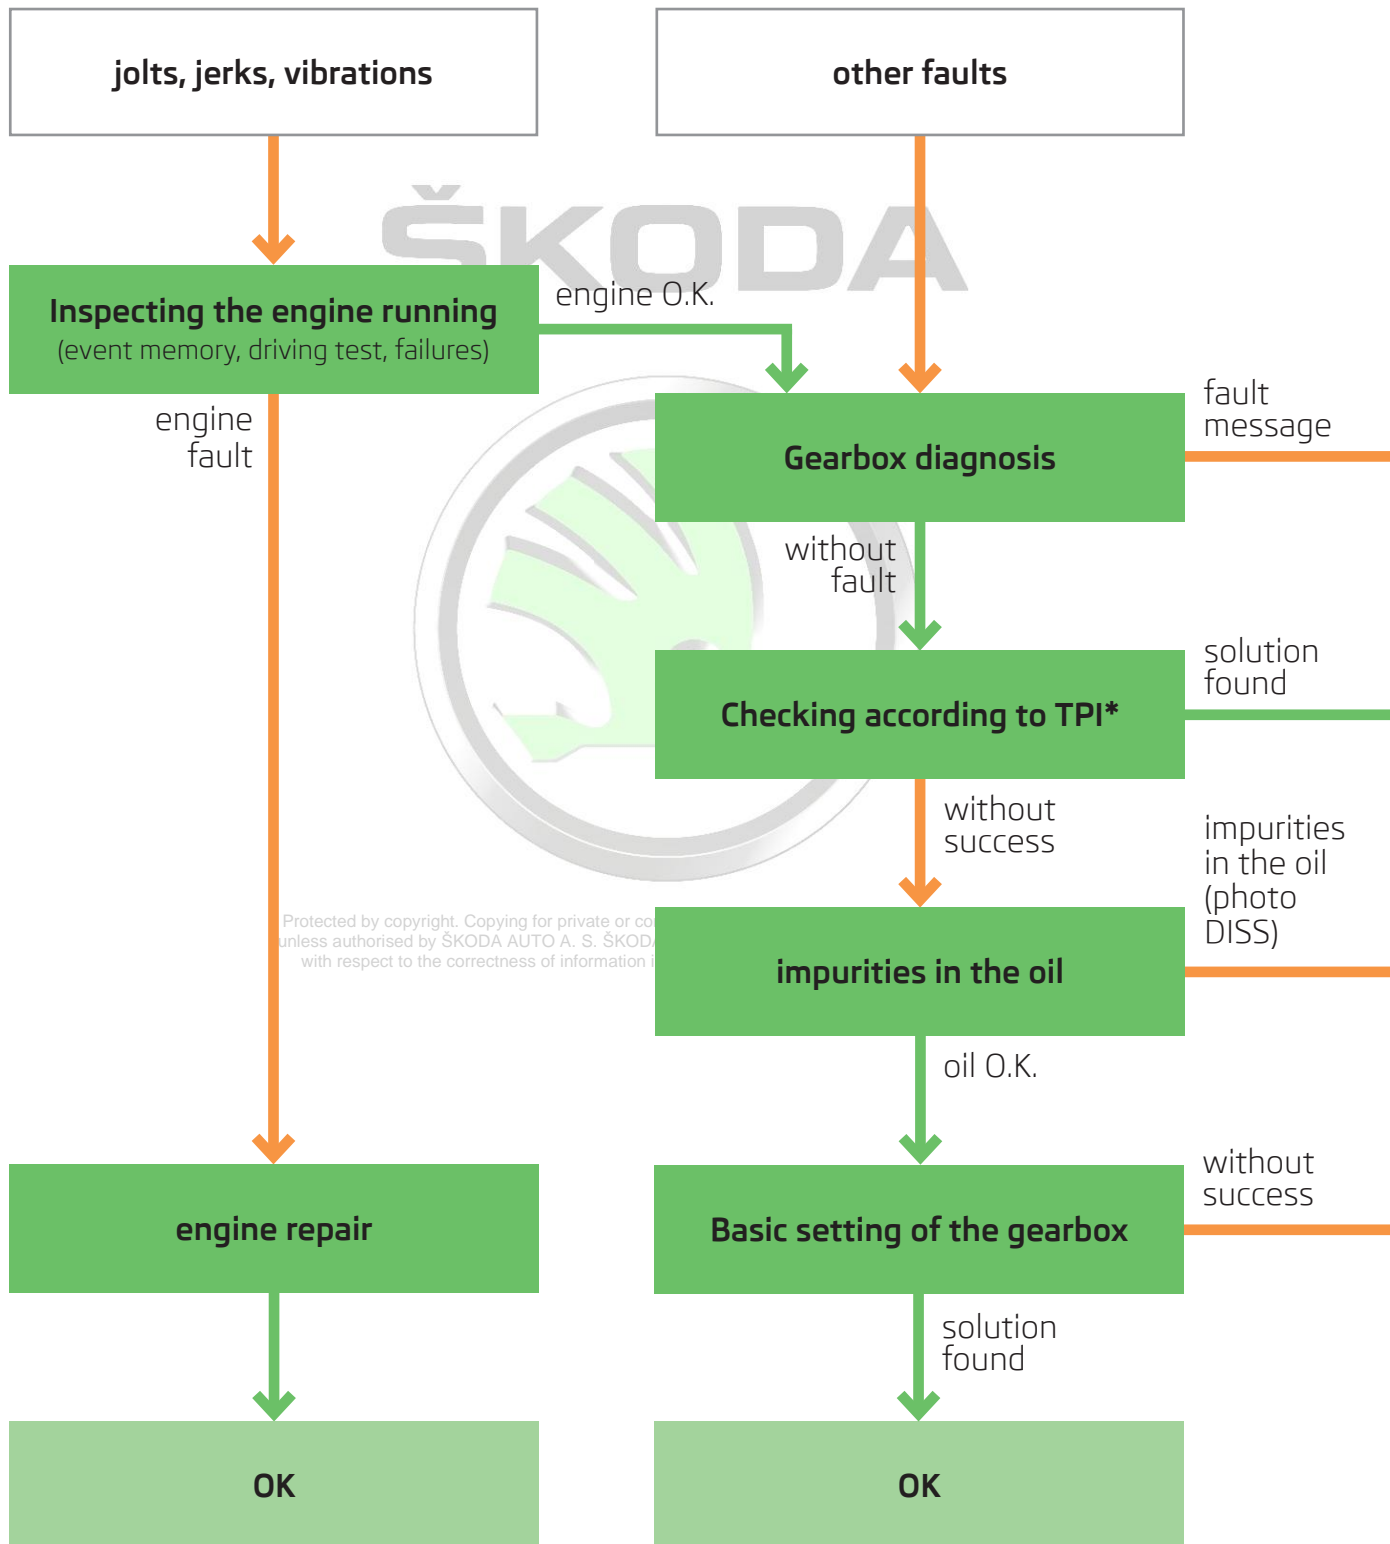
#### 4.1.4 Diagram of the recommended procedure for repairing the six-speed gearbox 02E

This is only valid for faults resulting from the operation.  
 (the diagram refers neither to the faults occurring after the repair nor to the faults occurring after replacing the gearbox components).

\* Checking according to TPI: Do not only check the fault but also the manufacturing period, referring to the TPI.  
 \*\* MP – Compulsory registration
